**LEAK DIARIES:  
REAL STORIES OF  
NON-REVENUE WATER  
MANAGEMENT POWERED  
BY EMBEDDED ALD**

# What is a Leak Diary?

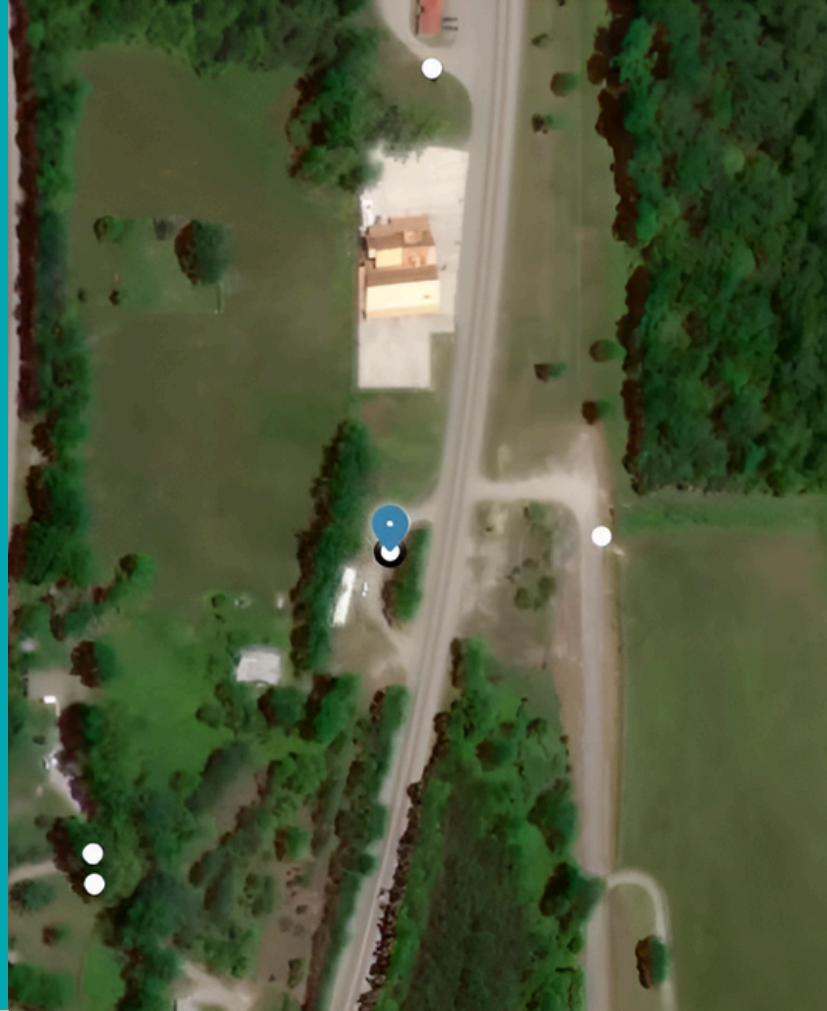
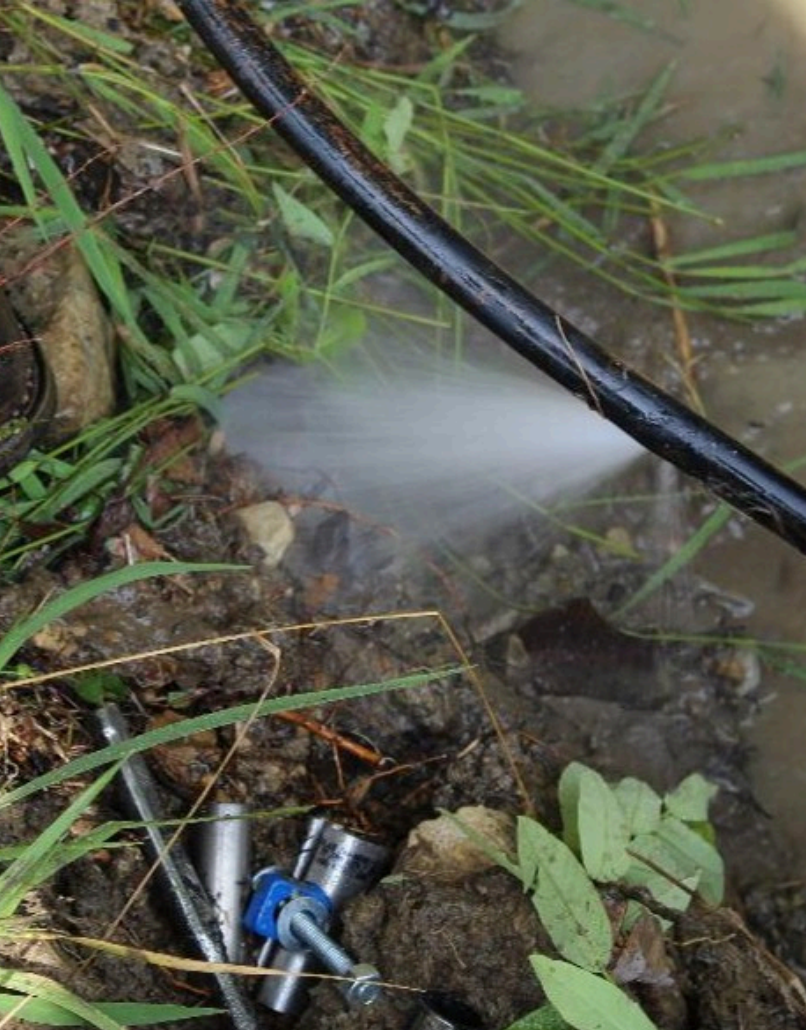
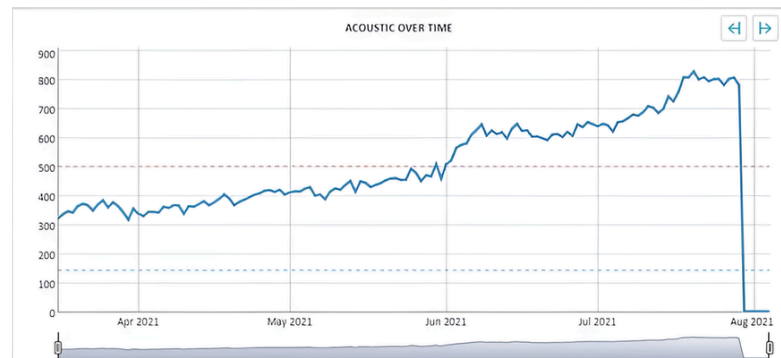
📍 Oneida, TN

A flowIQ® 2200 detected a non-surfacing, utility-side leak, located 50 feet upstream from the meter on a polyethylene service line. At 4 GPM, this leak was losing 111,600 gallons daily.

ALD listens inside the water column, enabling early leak detection, even on plastic pipe.

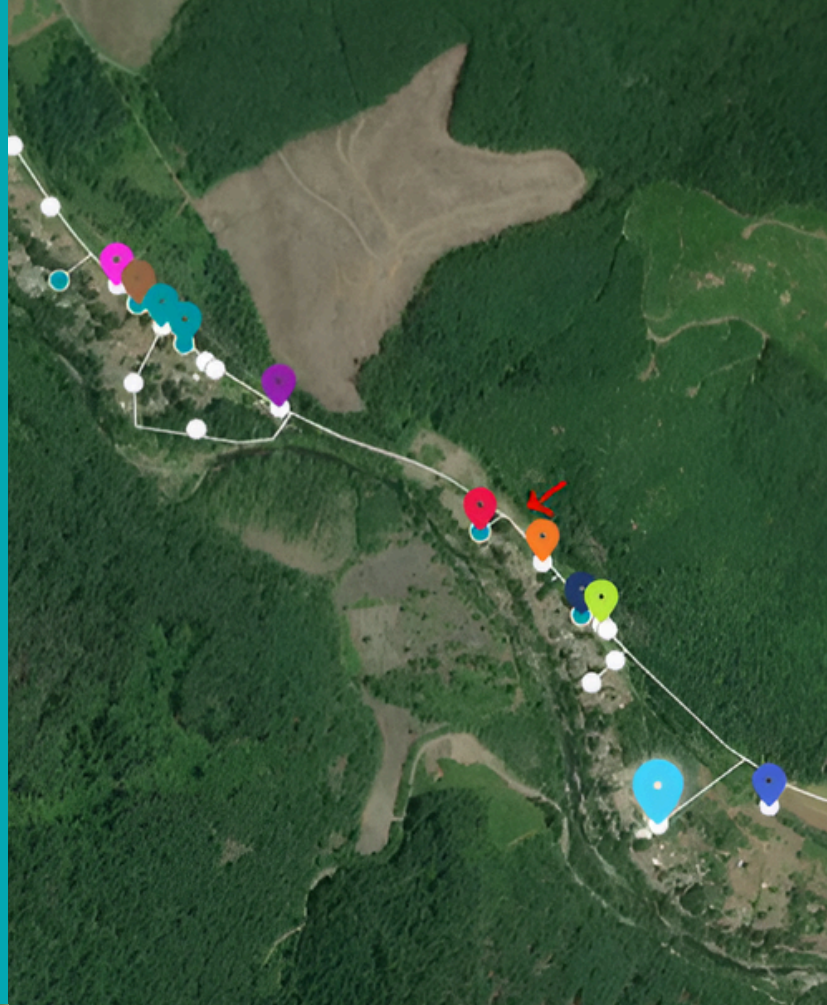
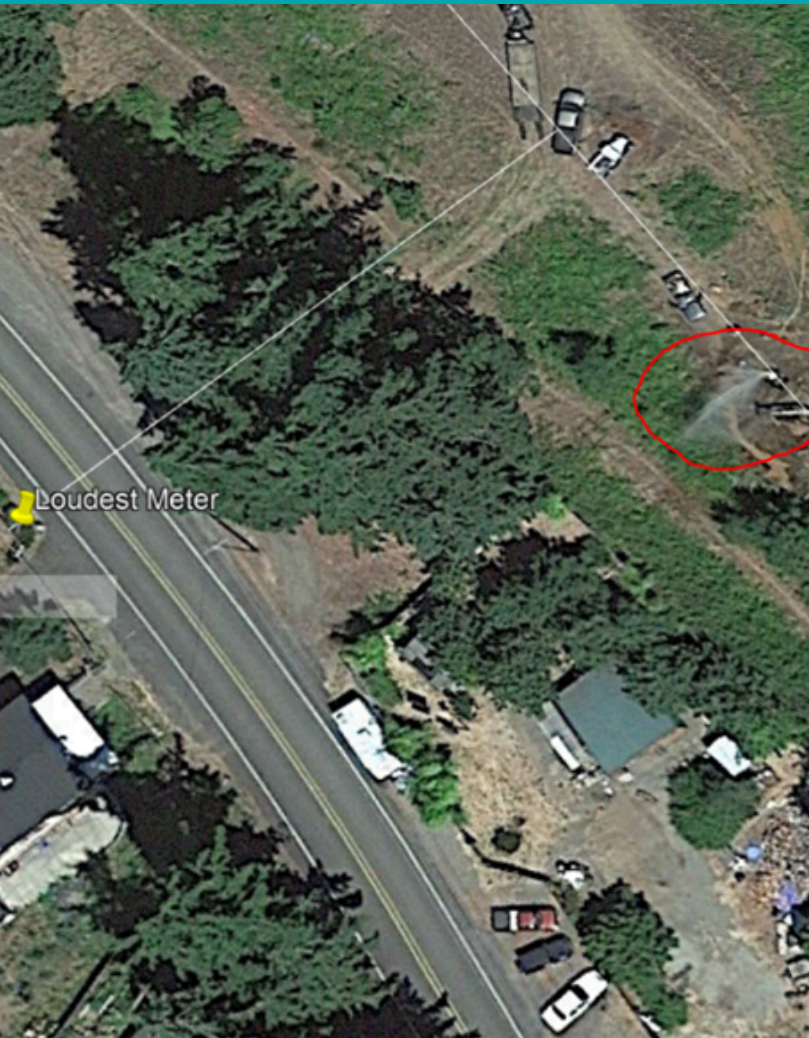
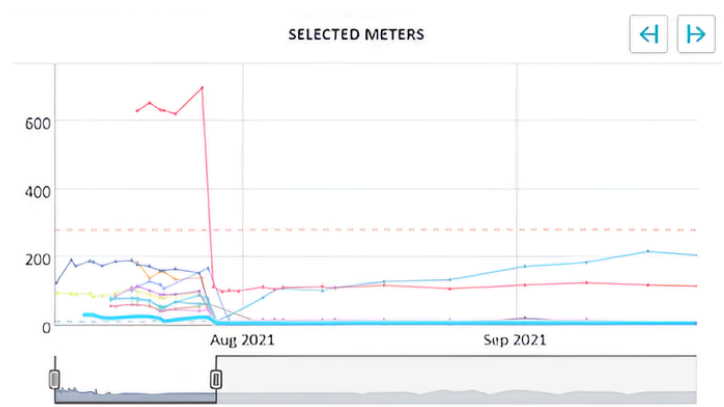
📍 Row River Valley, OR

In the town of Dorena, OR, a 30 GPM leak was reported by several surrounding flowIQ 2200 meters. The leak was heard on both ends of a 14" galvanized main by meters up to a half mile away.

With leak detection built into your infrastructure, long-range detection scales to network-wide monitoring.

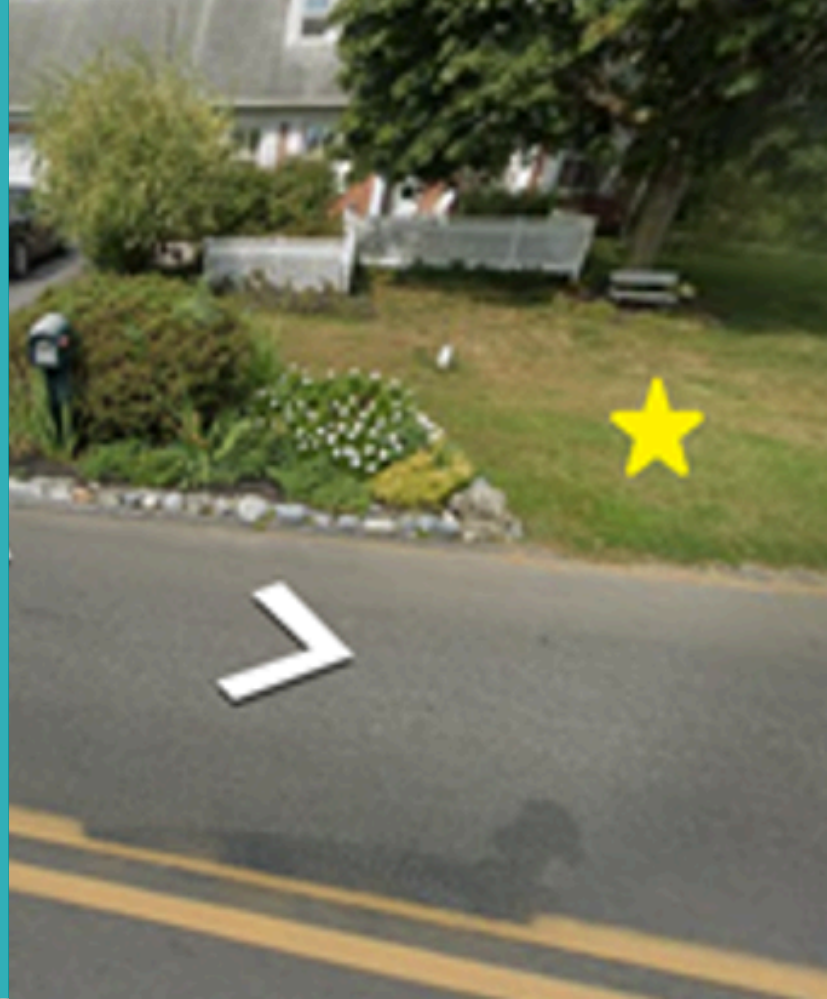
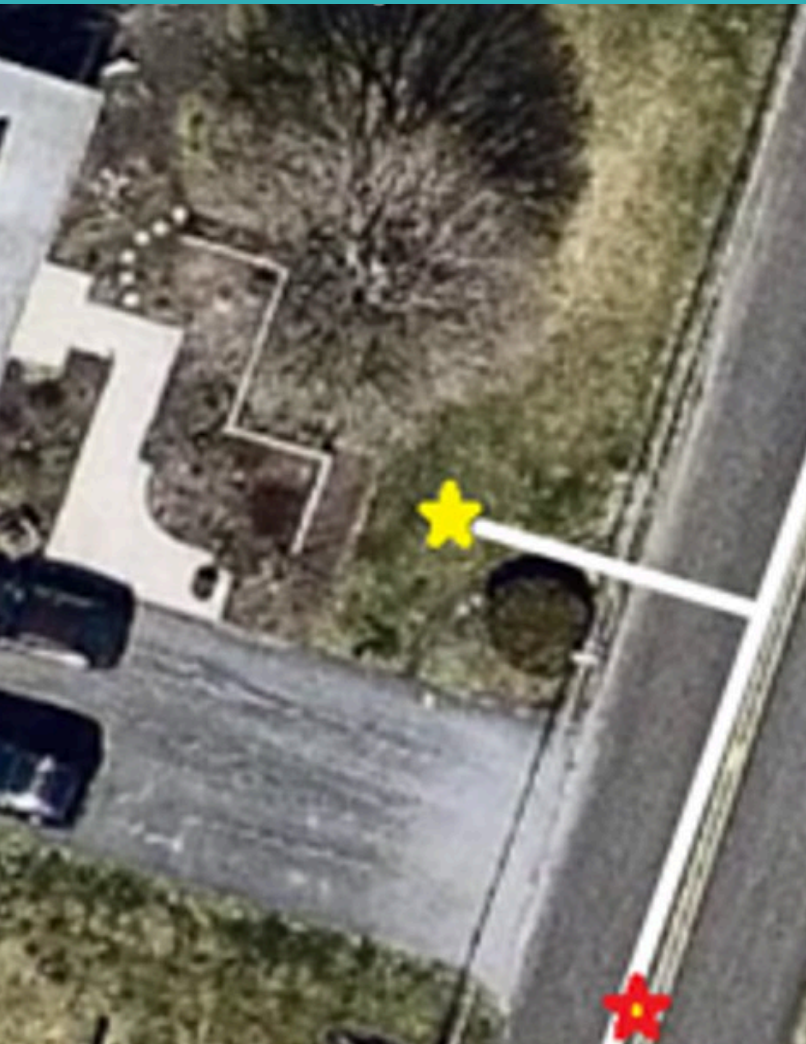
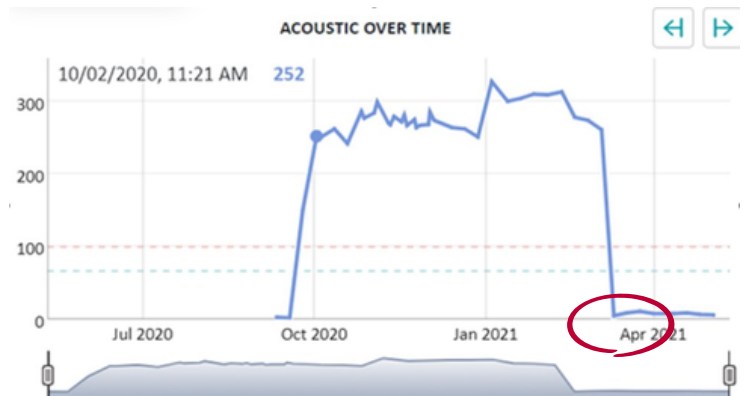
# Leak On a 12" Main

In Ephrata, PA, a leak from a stainless steel clamp on a 12" main was discovered with embedded ALD. The leak was detected by meters 55 feet away on a copper service line.

The utility was able to find the leak, manage it and fit the repair into their normal schedule. Following the repair, the utility saw a slight uptick in the acoustic signature, signaling a potential new leak set in motion by the return to normal system pressure.

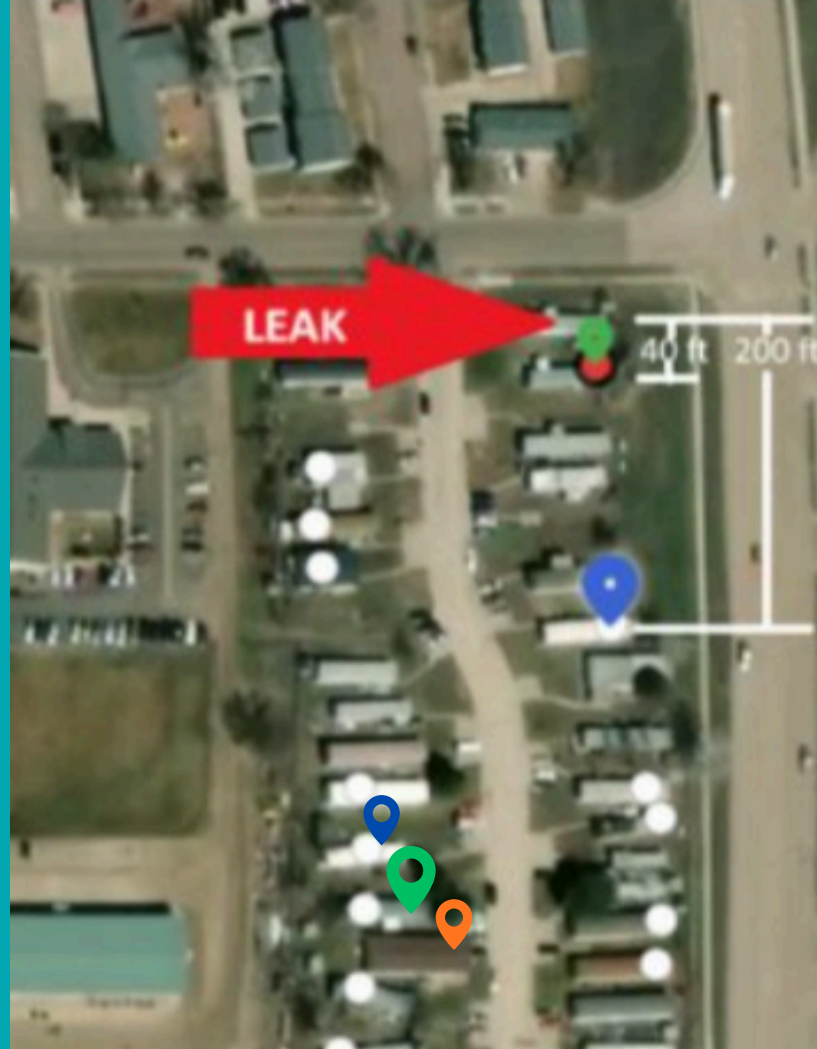
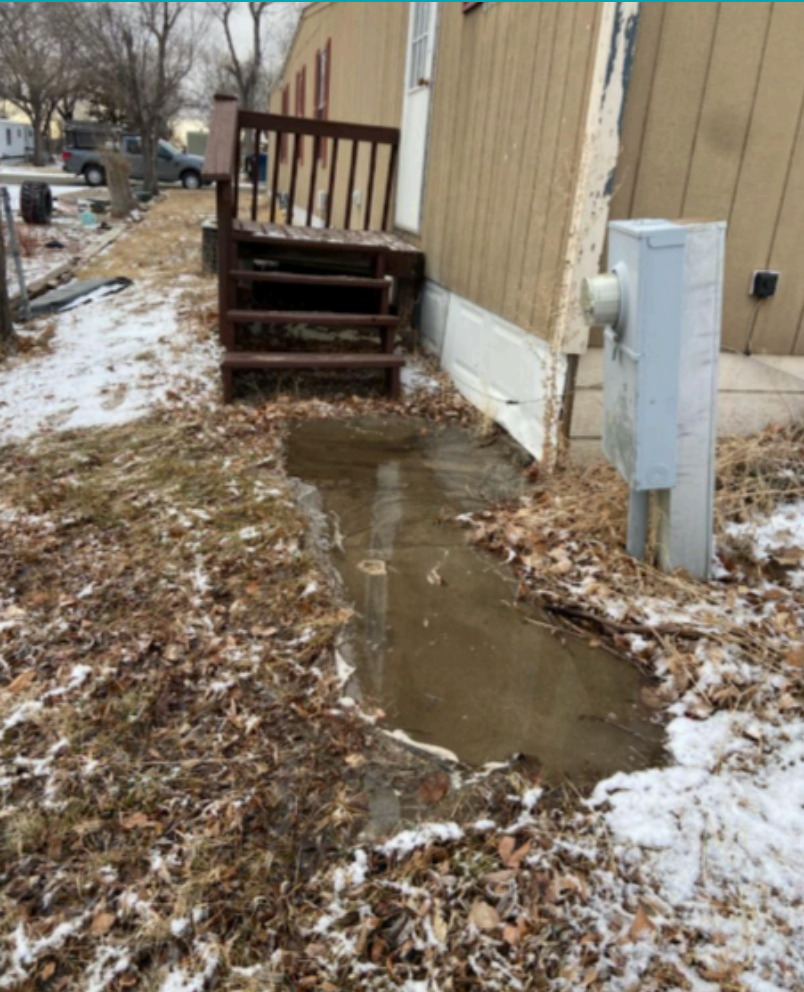
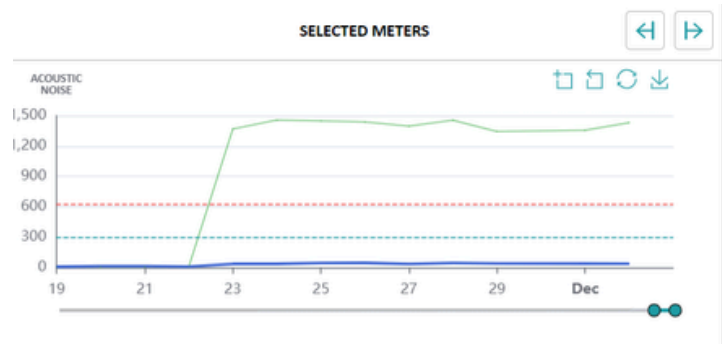
# Leak Detected Past a Competitor Meter

Through an ALD pilot in the City of Pierre, SD, a single flowIQ® 2200 meter installed in a mobile home park reported a nearby leak. When crews investigated, they found water coming through the floor of a vacant neighboring home — equipped with a competitor’s meter that failed to detect it.

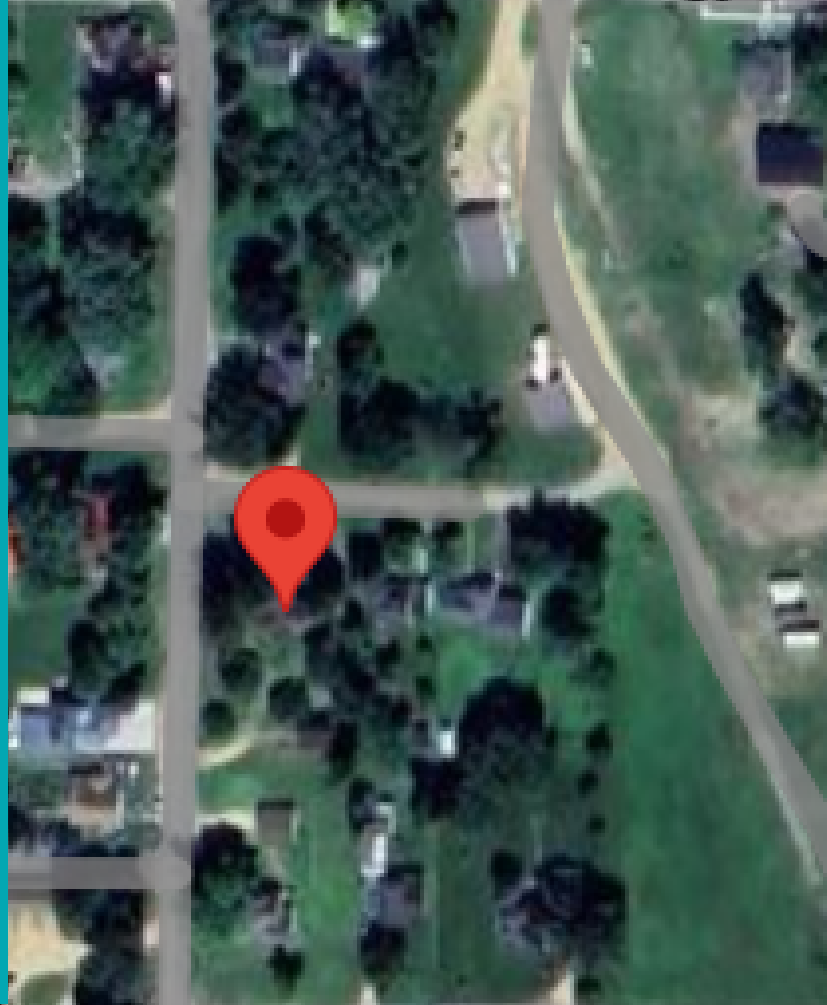
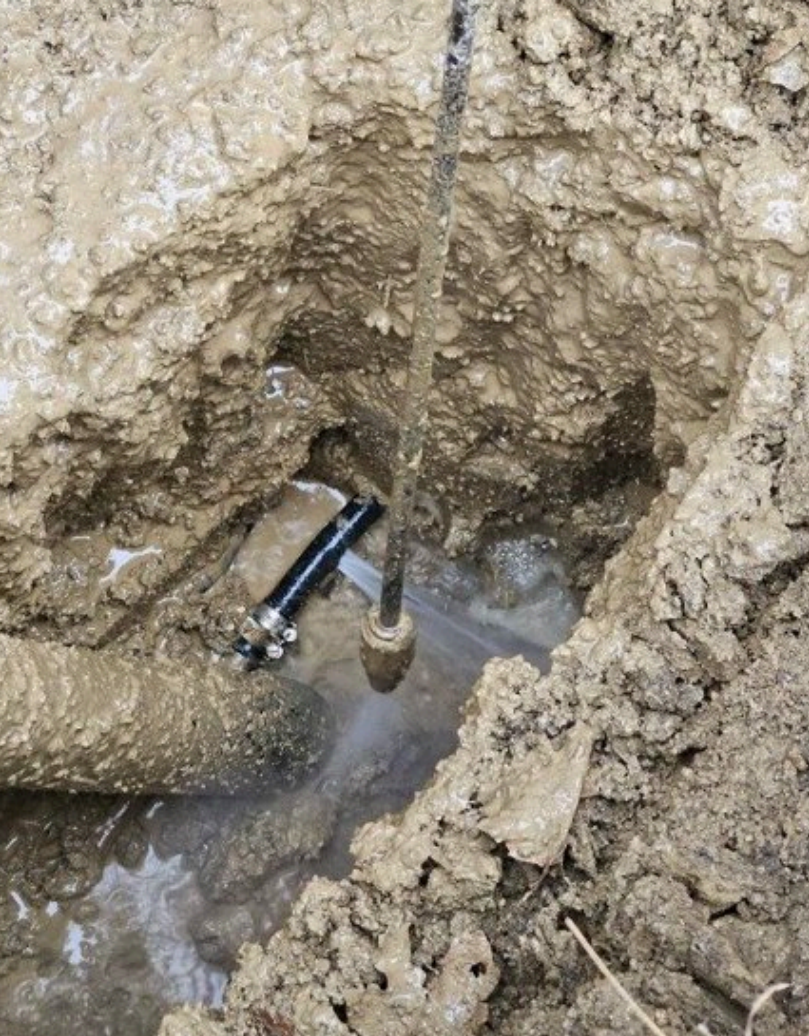
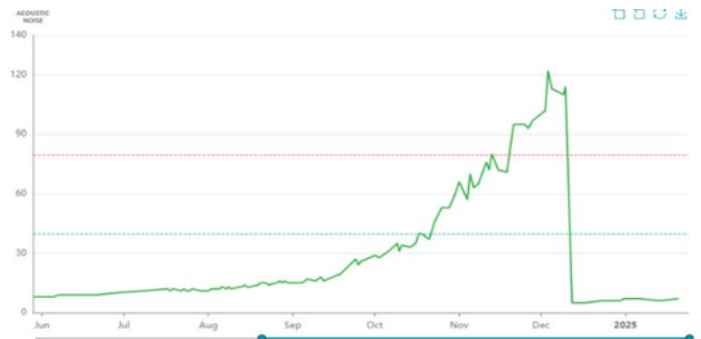
# Leak Found Inside a Curb Stop With AMR

A leak was found via Drive-By AMR (with built-in ALD) 2 feet inside a curb stop and 50 ft from the reporting meter. The non-surfacing leak was draining into a sewer.

Because the leak was found early, the utility was able to fix it before temperatures dropped. Freezing temperatures would have exposed the leak and likely forced a water outage for nearby homes along with a more costly repair.

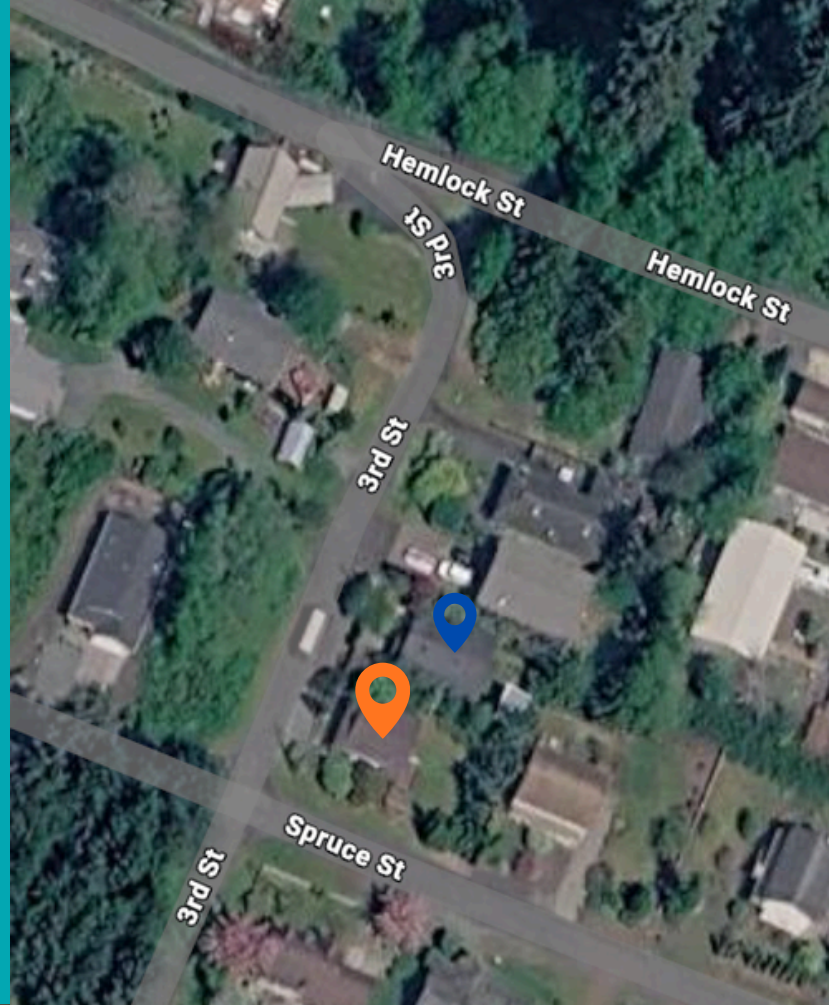
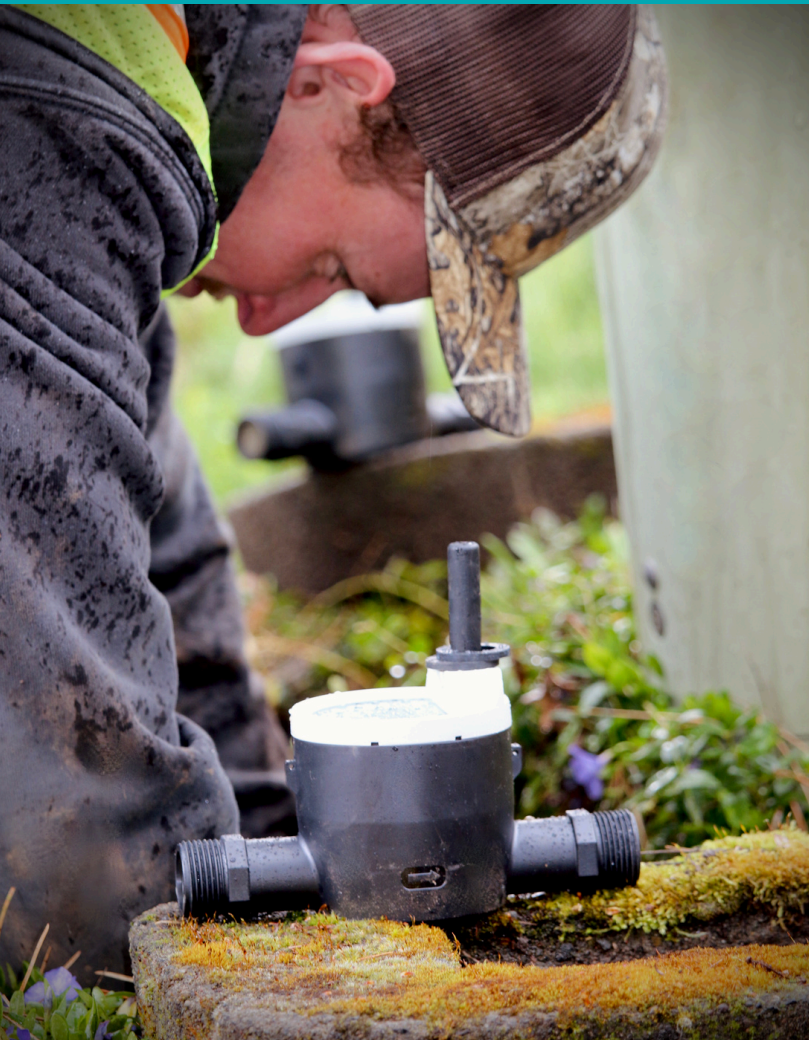
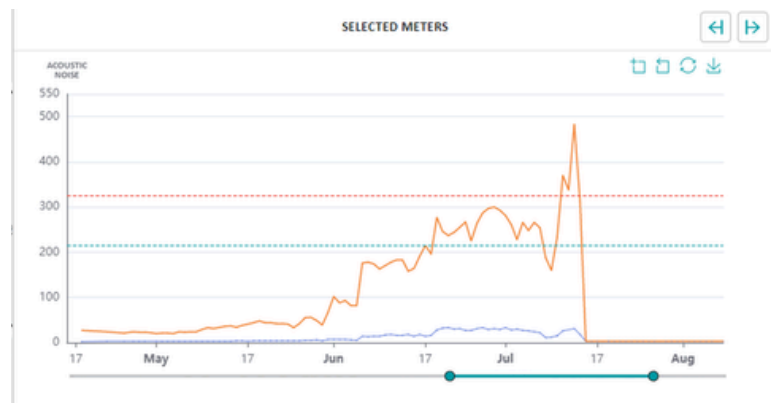
📍 City of Wheeler, OR

In Wheeler, OR a leak was detected by two meters, one of which reported a significant increase in noise. A crew investigated the specific meter and discovered a service line leak.

The higher orange line was able to identify the specific meter so that it could be scheduled and repaired.

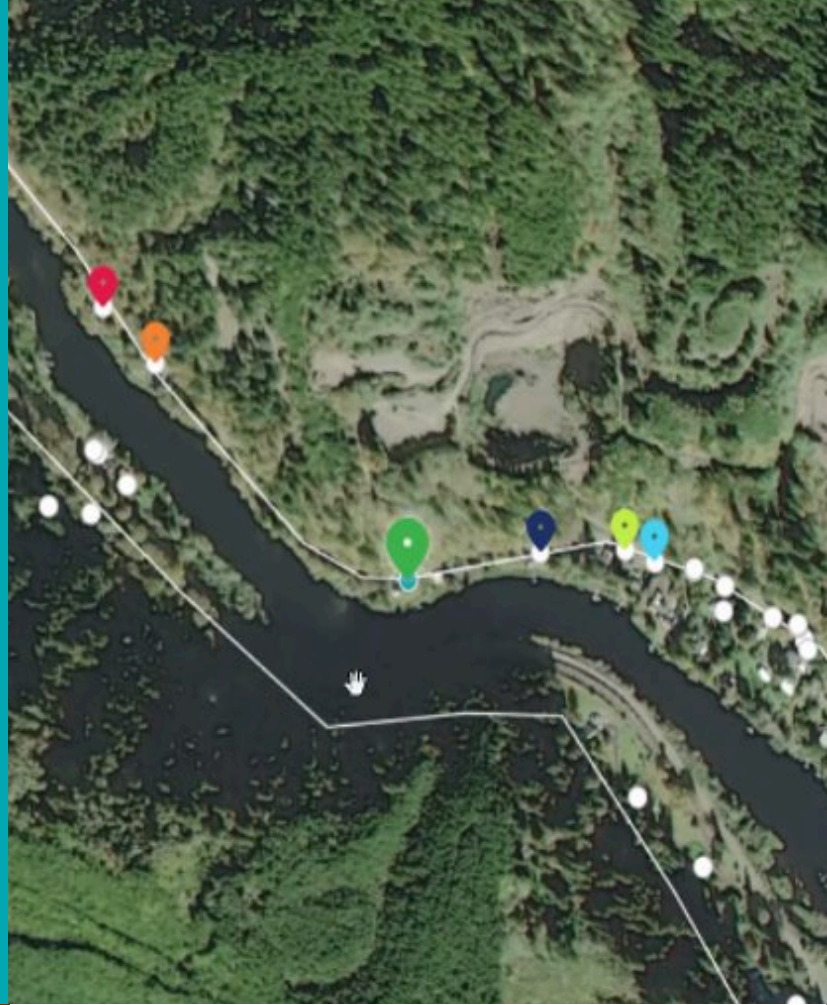
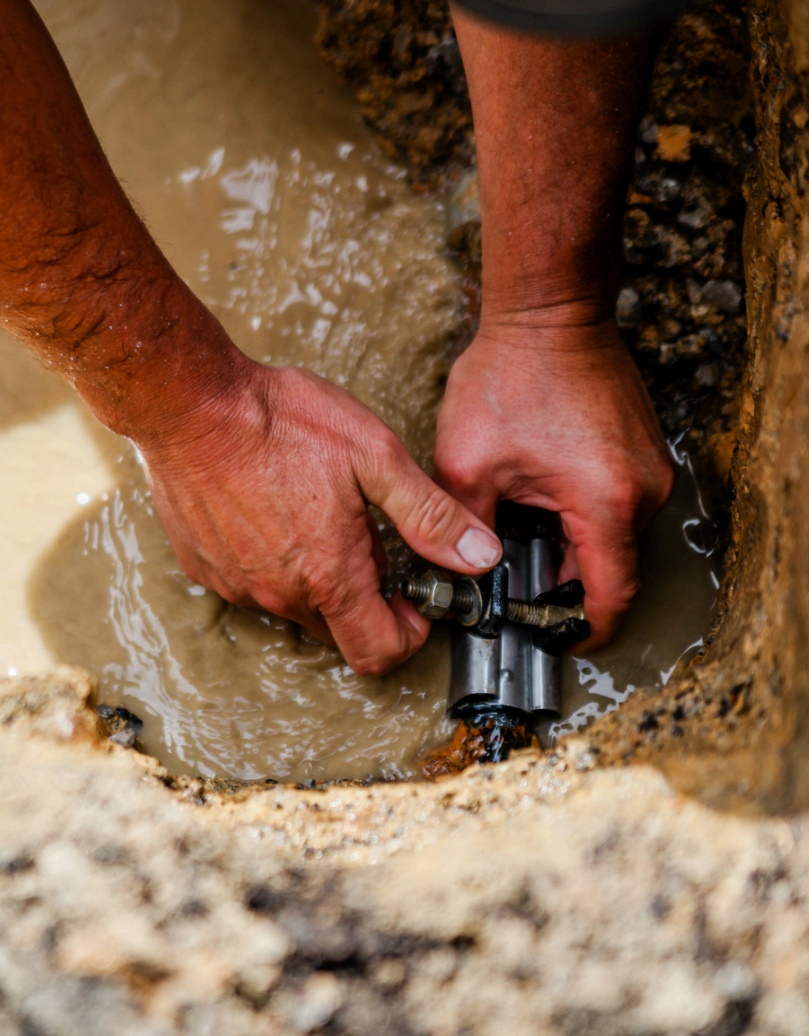
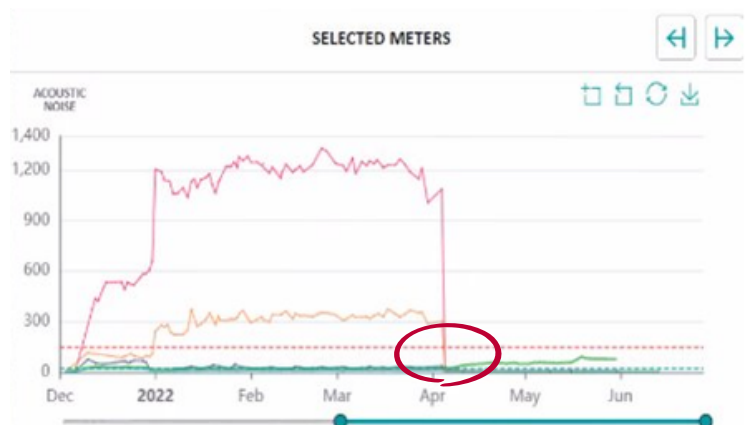
📍 Mapleton Water District, OR

A 180 GPM leak was detected, found, and repaired over 1500 ft from the nearest meter on a 6" AC Main. Over the following days, as pressure returned, a second leak sprang and was quickly identified with ALD so it could also be repaired.

The technology is able to continue to monitor even after a repair has been made so that potential leaks can be identified soon after a leak has been repaired and before the repairman has left the area.

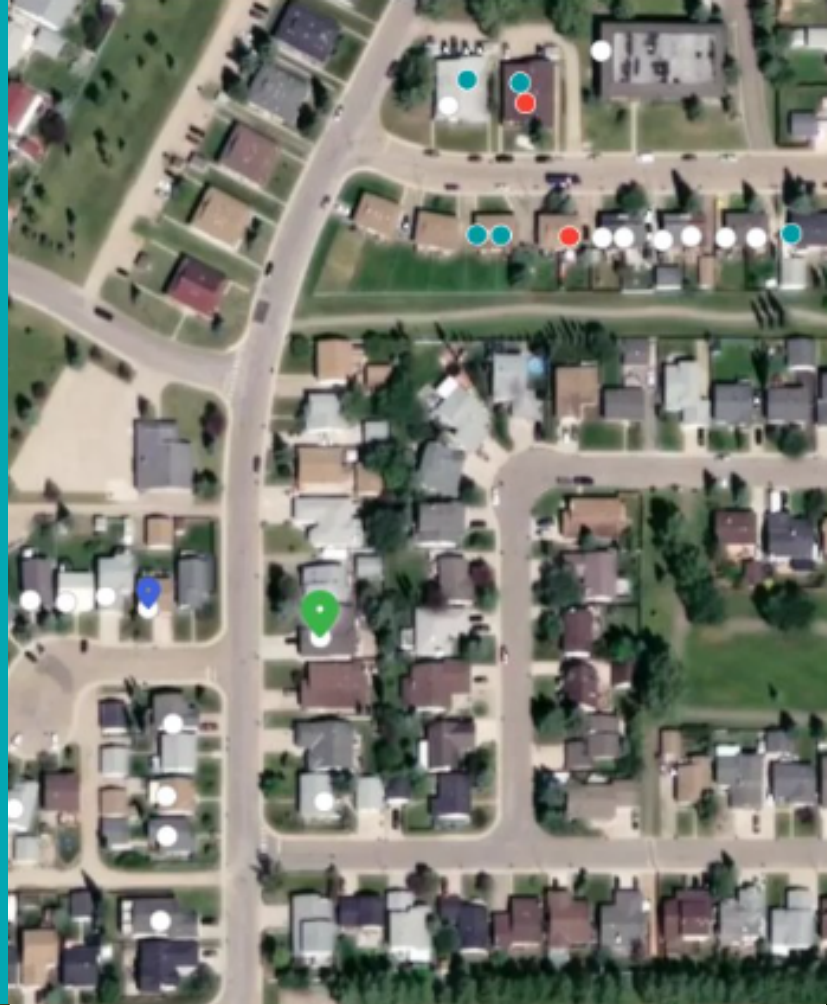
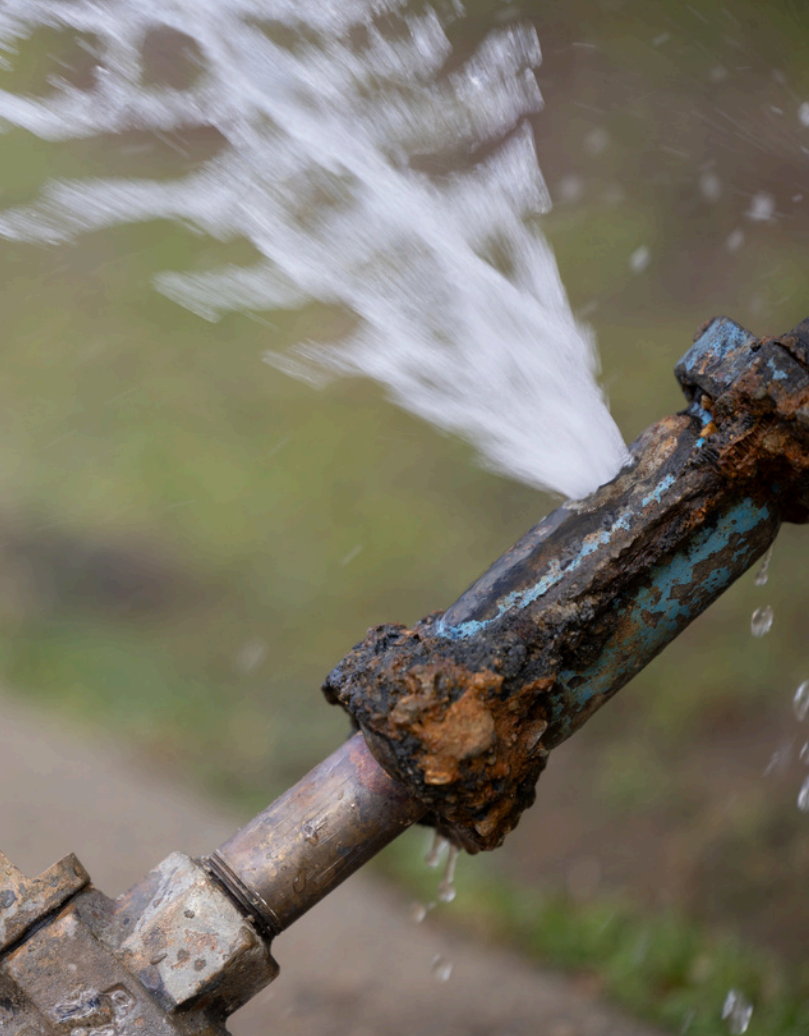
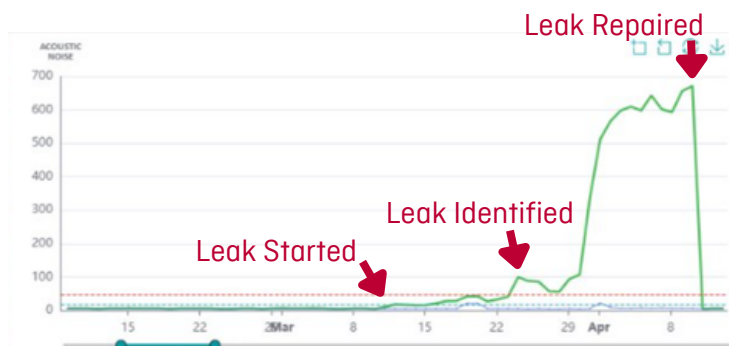
📍 Olds, AB, Canada

In Olds, AB, a 2 GPM leak was detected by an ALD meter approximately 50 feet away. The leak was confirmed and estimated to have been running for about a month, totaling ~86,000 gallons.

The leak repair was delayed due to the weather, but was monitored closely. It was completed the following April under safer, more cost-effective conditions.
